# Property Inspection and Evaluation Report

**Subject Property:** 49 L Street, S.E., Washington, D.C. , 20003-3352

**PHASE I  
ENVIRONMENTAL SITE  
ASSESSMENT  
49 L STREET SE**

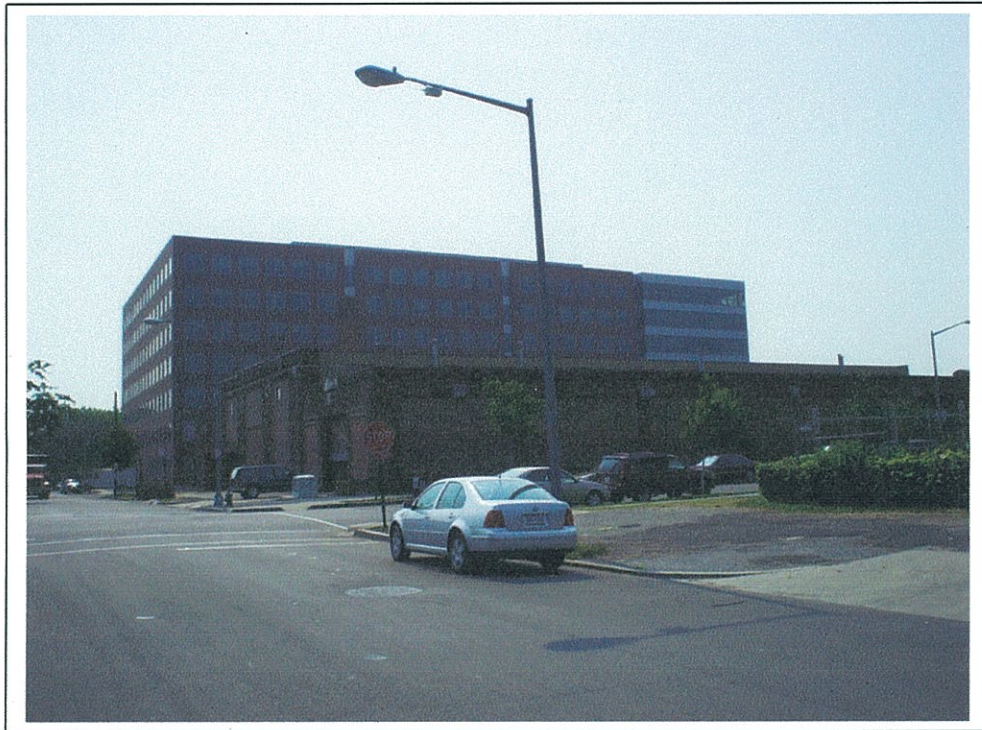
Subject is in foreground. Property to the rear is 80 M Street, S.E., which was completed by Spaulding & Slye in late 2000. Other photos follow text.

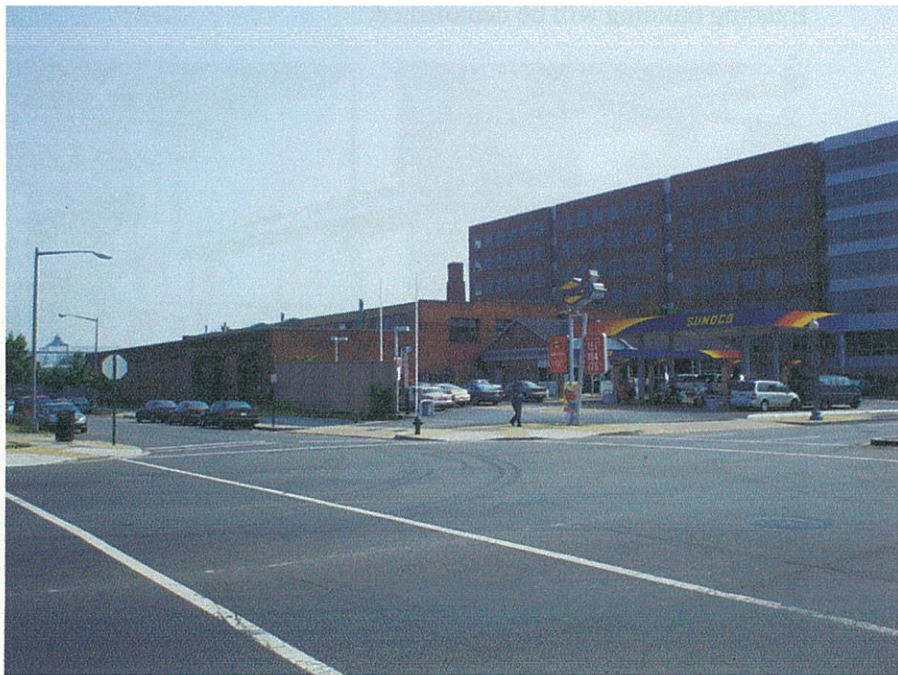
Subject is behind Sunoco Station. Property to right is 80 M Street, S.E., which was completed by Spaulding & Slye in late 2000.

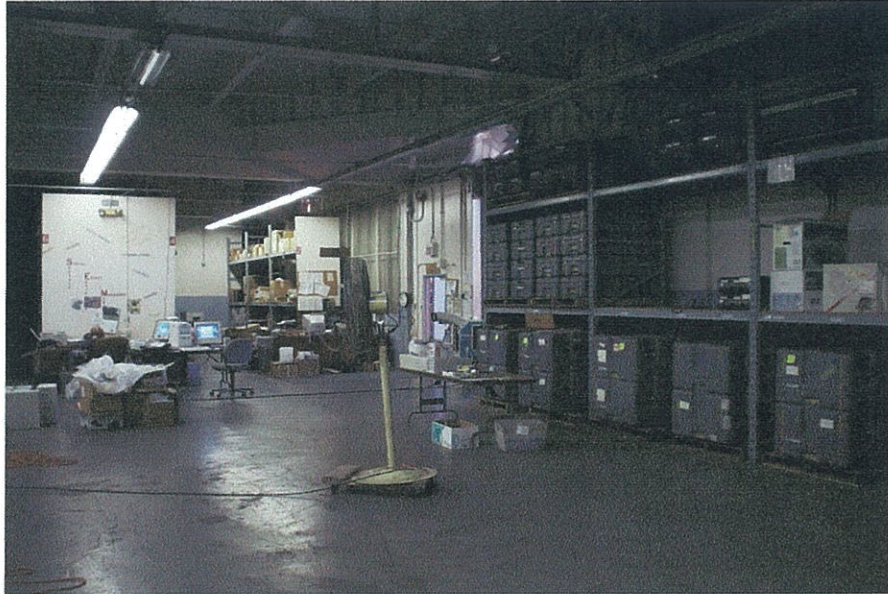
Side portion of warehouse. As noted in text, side areas on both sides of building are approximately 42 feet in width and approximately 16 feet in height.
